P R O J E C T
SAFE WINDOWS

Documenting Injury and Loss Prevention
in Hurricane Charley

Interim Report

August 30, 2004

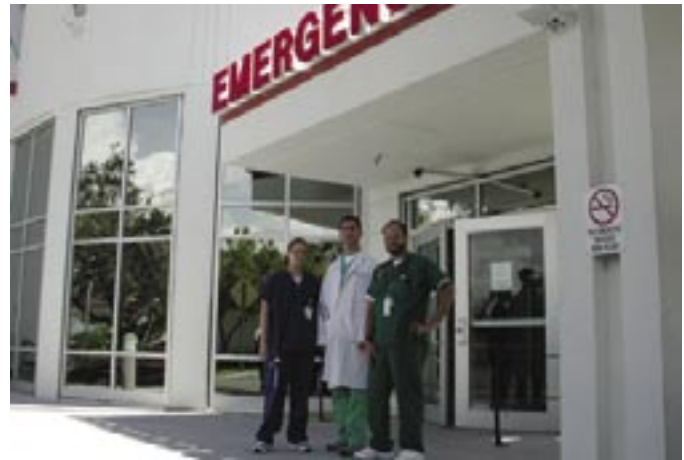
Some of the medical staff from the Bon Secours Saint Joseph Hospital are shown outside the new Emergency Department which withstood the hurricane force winds thanks to its laminated glass. The hospital remained open during the entire hurricane.

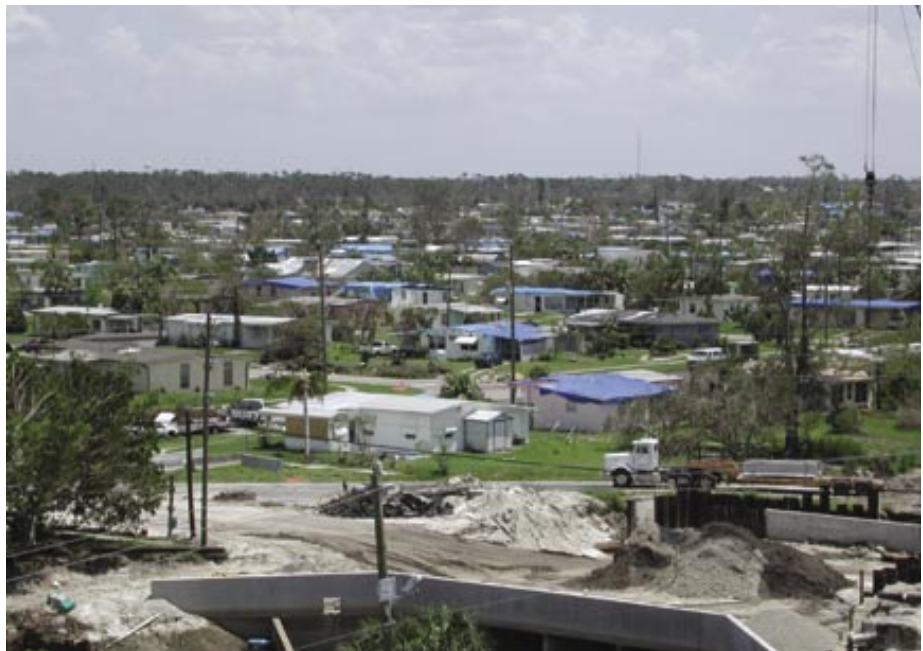
Taken from the roof of Bon Secours Saint Joseph Hospital, this image shows the massive damage done to this area of Port Charlotte, Florida.

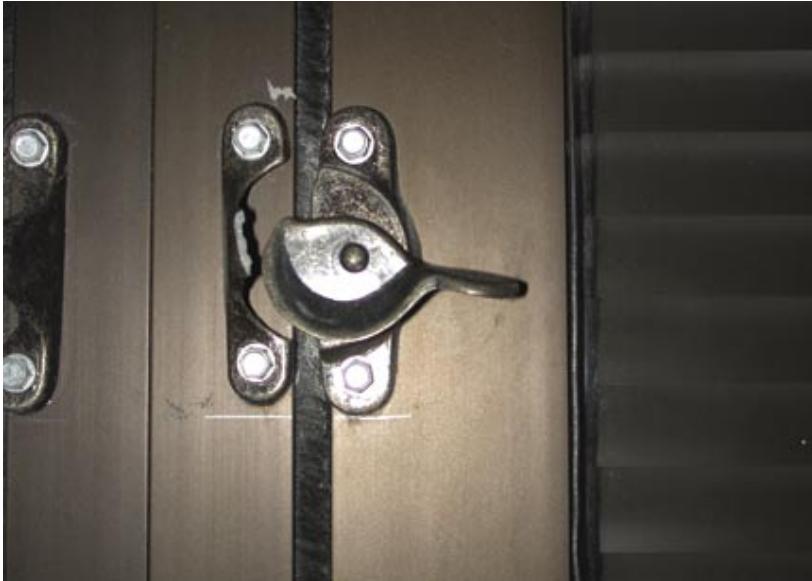
This photo illustrates the power of the winds generated by Hurricane Charley. The window locking mechanism on this upper story window was sheered off by the force of the wind, forcing the window open and driving wind swept rain into the hospital. Patients had to be evacuated as this unfolded.

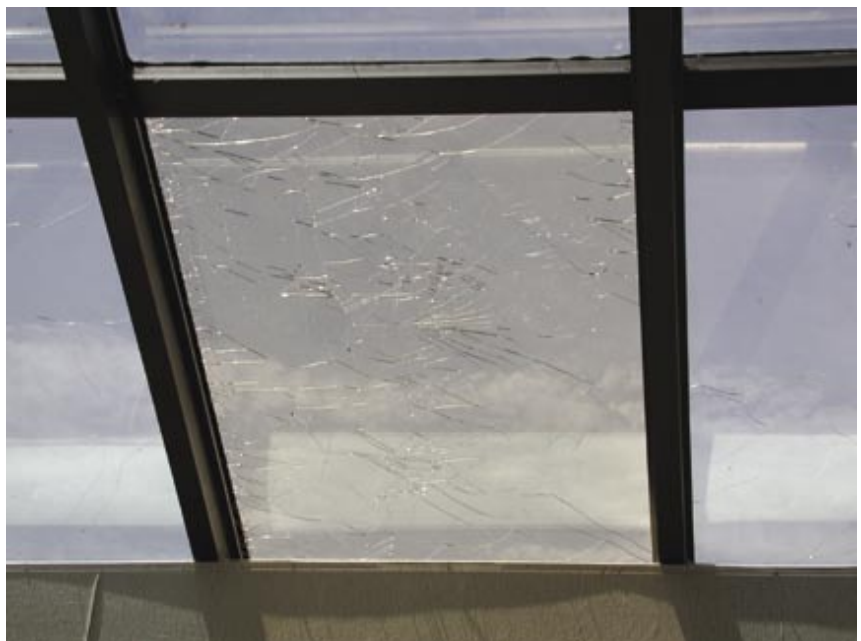
These overhead windows shattered in the storm but security window film kept shattered glass intact, preventing any falling glass in the hospital's main entrance.

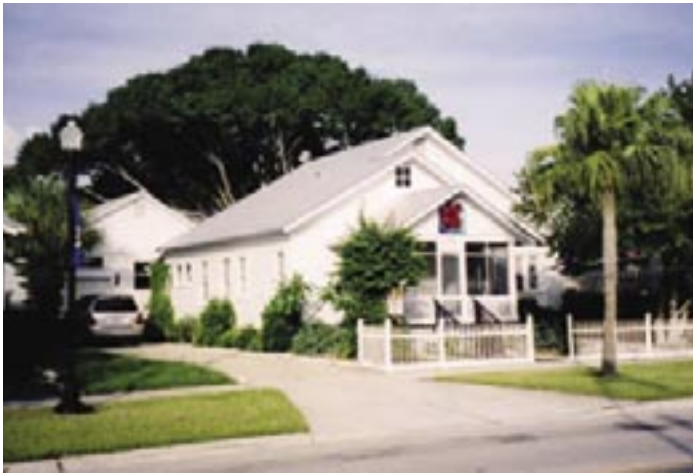
This image, taken on Friday afternoon before Hurricane Charley struck land, shows a quiet scene at the home of Liz Hutchinson. The photo below was taken Saturday morning after the hurricane passed over her town.

Project Highlights: This is a very compelling story. Liz Hutchinson owns a modest sized bungalow built in 1929 near the town center. Her home is surrounded on both sides by nearly identical homes, neither of which had security window film. Liz's home had window film on all windows except a small attic window. All but two of her windows were shattered and it appeared that the damage occurred due to smaller wind-borne debris, mainly roof gravel. Her windows looked as if someone had shot them with a shotgun. The window film held all of the broken glass intact, and there was no water intrusion from any of these windows. Unfortunately, the small attic window with no window film installed on it did give way, which led to some minor water damage and a fair amount of roof damage. Liz is an accomplished artist and has many of her original paintings hanging on her wall. She was extremely grateful that her artwork was saved by the film. I happened to be on hand when Liz's insurance adjuster inspected her house. When asked for his reaction to how the film performed, the adjuster said, "This is unbelievable. I've never seen anything like this." He asked that his name not be used in conjunction with his comment. While Liz was very fortunate, both of her neighbors, one who is also an artist, were not so lucky. Shattered annealed windows in the front of the neighbor's house west of Liz's house allowed

bathroom. The walls shook violently, and after the front windows blew out, the woman's husband had to struggle to hold the bathroom door from being sucked open. Her other neighbor suffered significant window damage from the same type of smaller wind-borne debris that struck Liz's bungalow. All three of these structures were built at the same time (1920s) by the same builder using the same construction materials. The window glass and frames were the same. Only Liz's had security film, and the resulting benefits were evident.

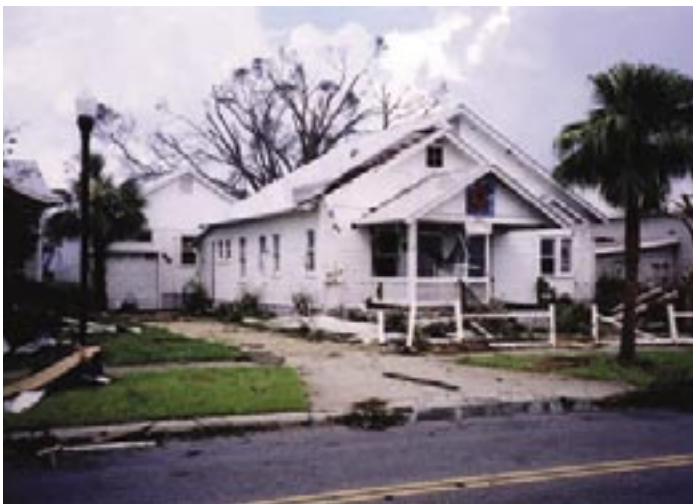
major water damage that destroyed many works of arts and a significant amount of framing equipment. This neighbor and her family, which included six adults and a dog, rode out this storm in an interior

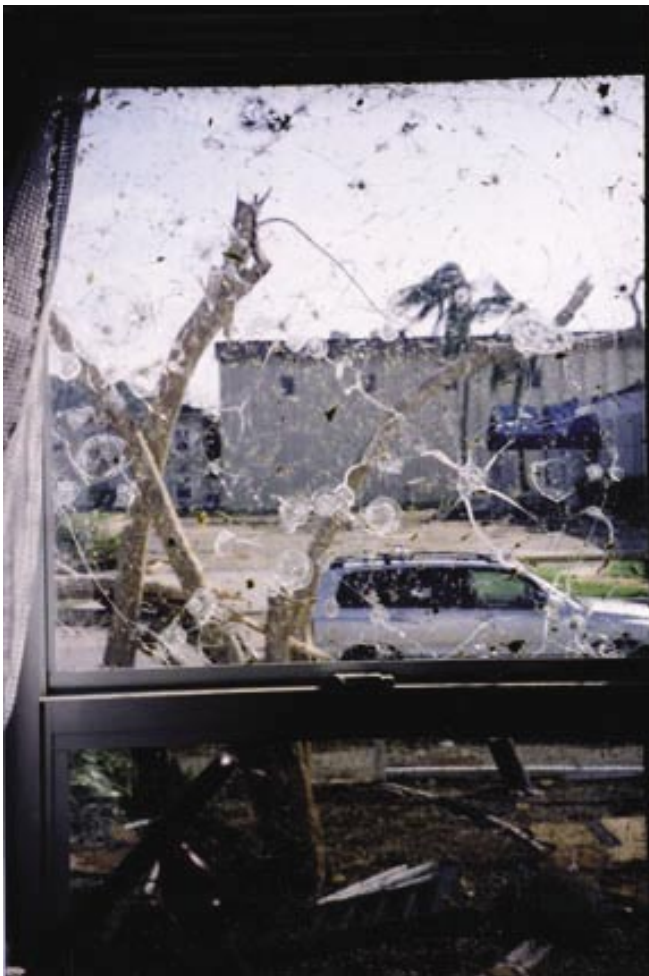
This image shows the shattered but intact window in the front of Liz Hutchinson's home.

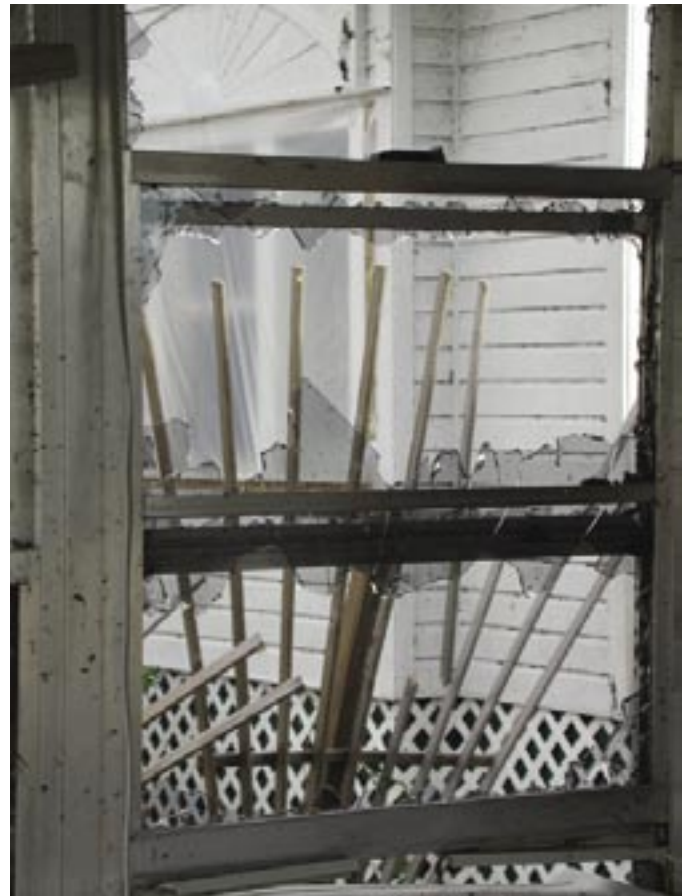
This image dramatically demonstrates the difference in window performance between Liz Hutchinson's home at 311 Taylor Street and her neighbor's home less than 5 feet to the north that did not have security window film.

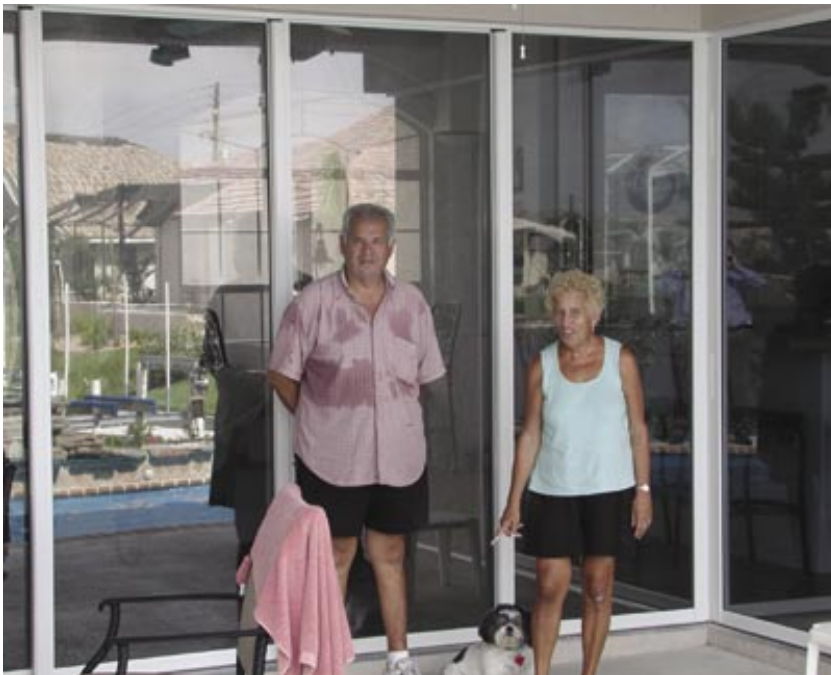
Project Highlights: This was the older couple who had large sliders and had installed film on every window. They lost a small bathroom window to a piece of flying aluminum, which caused some water intrusion into the bathroom. They also had one window in an adjoining bedroom shatter, although the window film held the broken window intact and no water entered the house from this window. By comparison, the two homes on either side of the Granado and Jones home suffered major window failure. As a result, both homes suffered extensive water damage.

Mr. Jessy Granado and Mrs. Teddie Jones are shown in front of a large bank of sliders at their Punta Gorda home. The couple is pictured below in their bedroom where flying debris shattered a window. Security window film prevented any water intrusion into the bedroom.

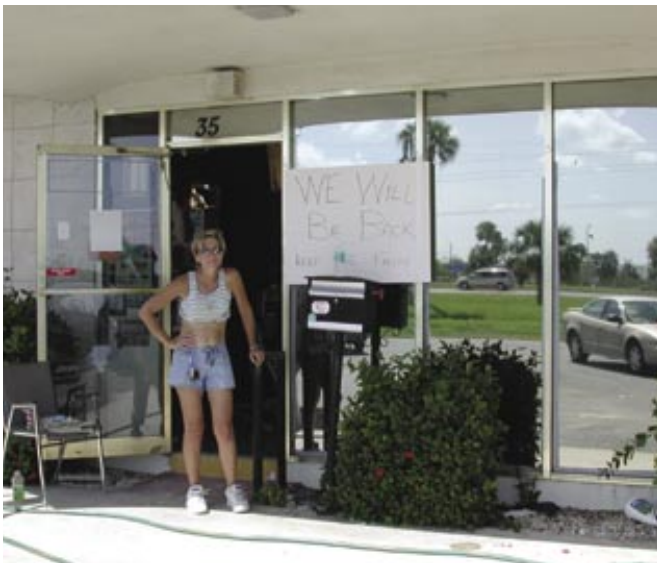
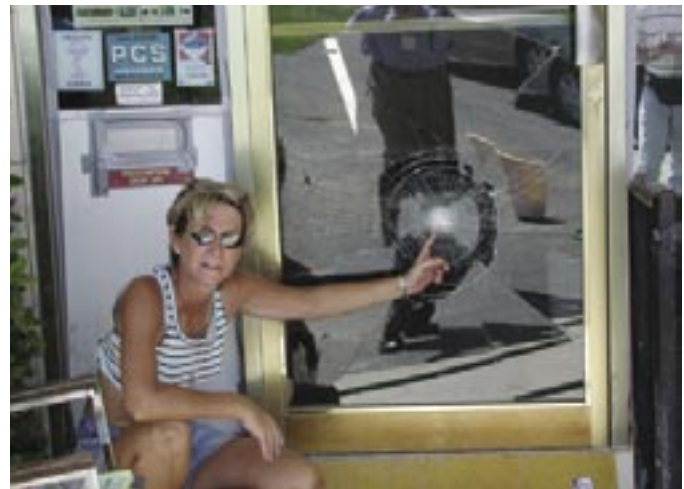
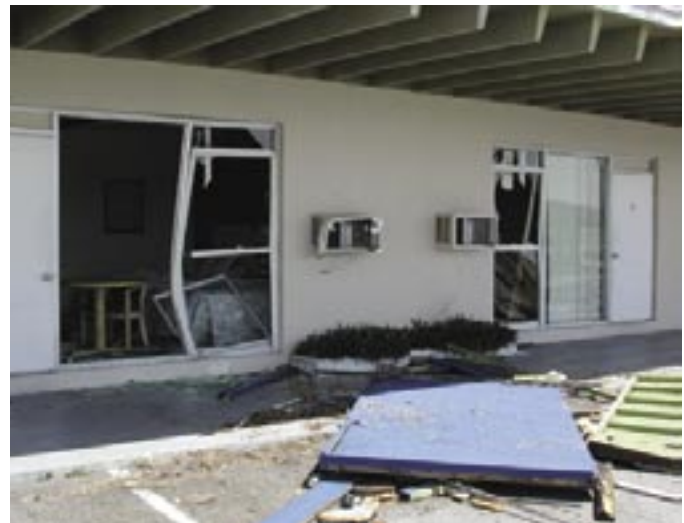
Project Highlight: This was an interesting combination success story. The pharmacy is located in a small strip mall that is anchored on one end by a two story doctor's office. All of the windows in this strip mall remained unbroken, despite massive numbers of broken store front windows in all directions from the pharmacy. In addition to protecting the pharmacy from the ravages of Hurricane Charley, the window film also deterred a looter from breaking into the store and stealing pharmaceuticals. This attempted break in occurred three days after the hurricane passed through. The thief was deterred from entering the pharmacy due to the presence of the window film. NOTE: While the security window film performed well during the storm, the roof of this strip mall did not survive the storm. As a result, the pharmacy sustained major water damage.

Nina Wallace, bookkeeper for a retail pharmacy in Port Charlotte, points to the impact point where a looter tried to break into the pharmacy to steal prescription drugs three days after the hurricane. Security window film deterred the robber. Nina is shown above, illustrating her store front windows, that were unaffected by the storm. In stark contrast, another image (right) was taken of a building less than one mile from the pharmacy that had no protective glazing.
